Redeeming Grace

A biological remediation process saves a Georgia family from replacing a failed gravel drainfield

**ONSITE
installer**
February 2008

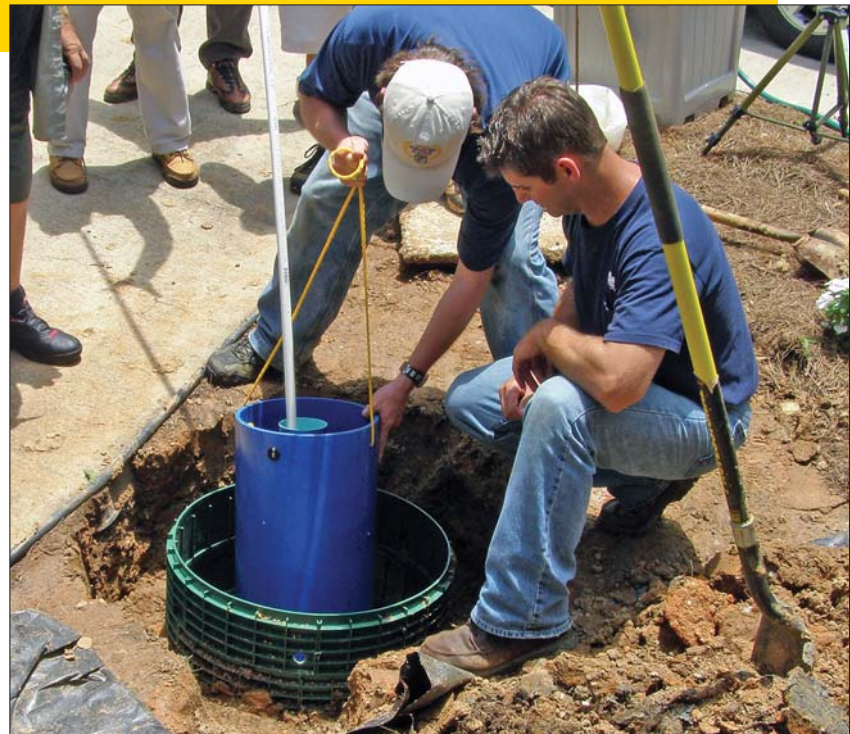
Brian Parker guides the Aquaworx Remediator into the septic tank. It must sit firmly on the bottom and below the riser for easy access. Matt Vinson looks on. (Photos courtesy of Infiltrator Systems Inc.)

They lowered the ABG into the tank using the supplied rope. “The rope is made of non-reactive material because it stays in the tank and is used to remove the unit for future maintenance,” says Parker. The ABG was positioned with the air-line assembly as close as possible to the riser’s inside wall. Parker then bounced the unit on the bottom of the tank to seat it. “You can feel it settle,” he says. “If improperly seated in a lot of sludge, the column begins to tip.”

Because the unit merely sits on the bottom, the rigid air-line assembly added stability when glued in place. ABG installation took 30 minutes and the preparation about two hours. Within two weeks, the remediator restored the system to working condition with no signs of ponding at ground level. Complete restoration is expected in six months.

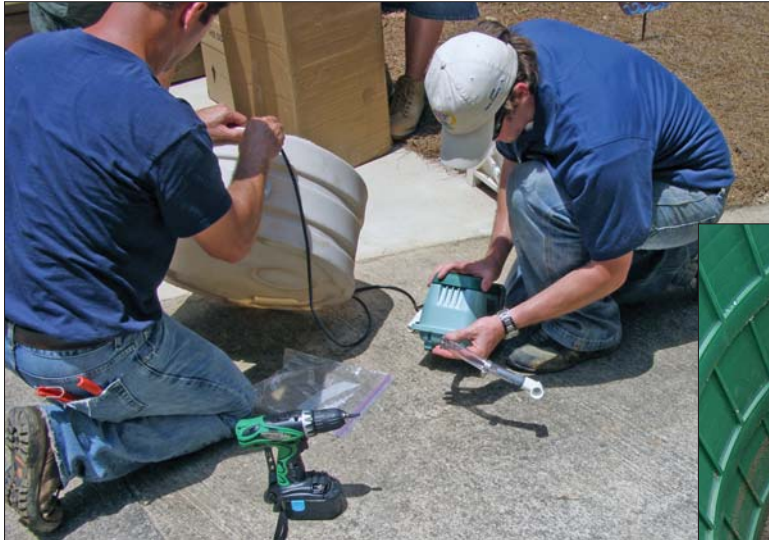
At left, Matt Vinson and Brian Parker prepare to install the air pump and its protective plastic basin. Below, a close-up of the aerobic bacterial generator at work five days after installation.

After mounting the air pump’s

waterproof basin under the outdoor deck near an electrical outlet, the men used shovels to dig a 20-foot-long trench 4 to 6 inches wide to bury the air line. “A depth of 8 to 12 inches is adequate,” says Parker. “The aim is simply to hide it.”

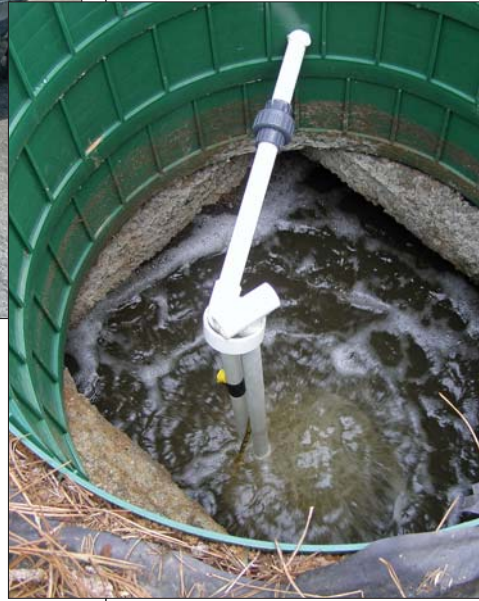
“Agitating the wastewater initially releases unpleasant odors that disappear after a day or two. A foam or bubbly floc may appear for a week or two, but that’s normal and can be washed down with a hose.”

As effluent flows by gravity to the drainfield, bacteria migrate with it to consume the clogging biomat and improve the nitrification phase. Increased hydraulic efficiency is noticeable within weeks. The remediator is not an advanced treatment unit.
